Manhole Inspection Summary

Manhole # S33Y1_001MH

Location Address: **121 Old Riverside Road**

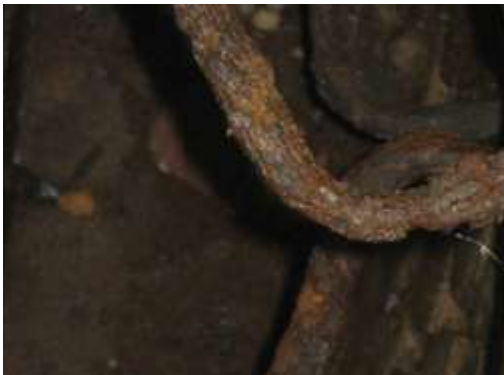
Defect 2

Count: **3** Missing: **0** ☒ **Corroded**

corroded steps

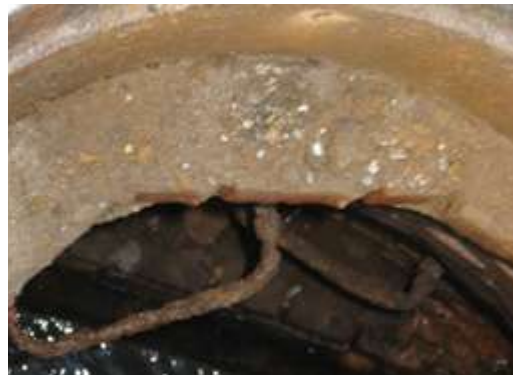
Defect 1

Offset: **2** (in.)

frame offset

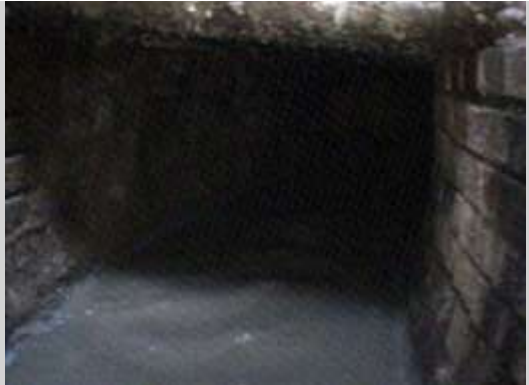
12 O'Clock Outflow

27 in. Circular Gravity Sewer
Pipe Out @ 12 O'Clock

Pipe Height: **26.4** (in.) Rod and Bar (Angled)
Pipe Material: **Clay** ☐ Pipe Lined
Invert Depth: **7.96** (ft.) Flow Characteristics: **Fast**
Deposits: ☒ None ☐ Mud ☐ Sludge ☐ Debris ☐ Grease
Silt Depth: (in.) Deposits Extent:
Infiltration: **None** Pipe Seal Cond: **Sound**

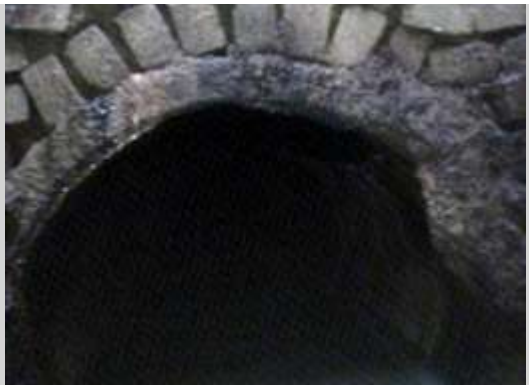
6 O'Clock Inflow

27 in. Circular Gravity Sewer
Pipe In @ 6 O'Clock

Pipe Height: **26.4** (in.) Rod and Bar (Angled)
Pipe Material: **Clay** ☐ Pipe Lined
Invert Depth: **7.82** (ft.) Flow Characteristics: **Fast**
Deposits: ☒ None ☐ Mud ☐ Sludge ☐ Debris ☐ Grease
Silt Depth: (in.) Deposits Extent:
Infiltration: **None** Pipe Seal Cond: **Sound**
